Herdt Home Inspections

Date of Inspection: October 1, 2008

Address:
Dillon, SC 29536

Inspection #: 281003

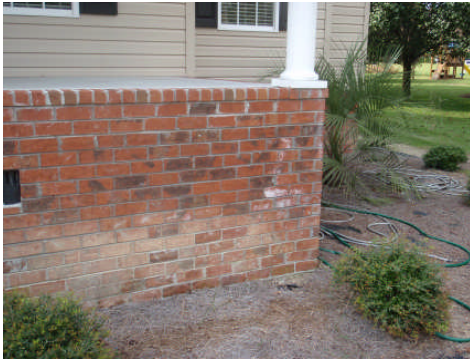
Front porch is covered suspended slab with brick surround and steps and is sound. **There are no railings in place at any porches/steps. Railings are needed at all to prevent falls due to height above grade**

Front porch over 4' above grade

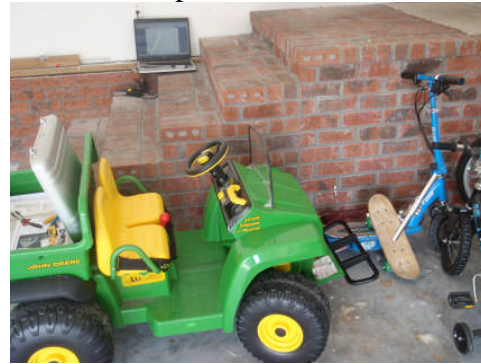
Garage steps 6 high, over 34"

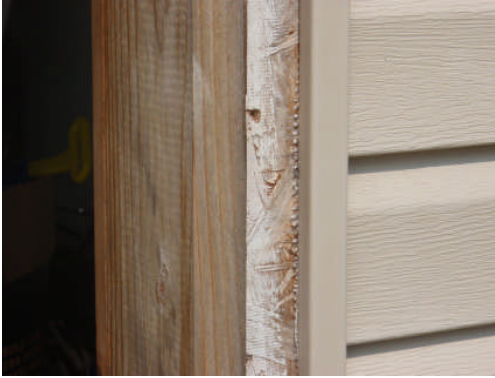
Trim paint condition: virtually all of trim is metal or vinyl clad and is sound **except at garage door (vehicle and rear) areas where trim is not complete. Proper completion is needed to prevent water damage to wall systems in these areas.**

Final application of paint is needed at wood trim of door surrounds

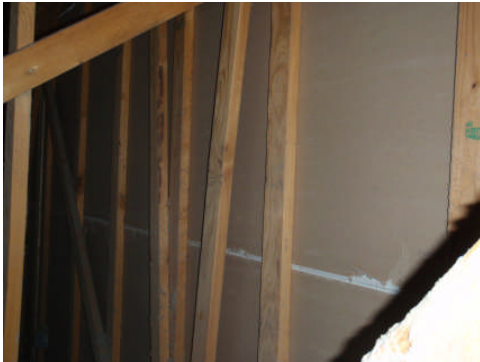
Insulation (approx. R value): **15-19 where visible (R-30 has been SC Energy Code standard since 1984). There is none visible at peak area (limited access). Large areas of side walls of heated second floor area have no insulation installed (R-15 needed). Correction is needed to reduce energy consumption.**

No insulation on sidewall at north side of house

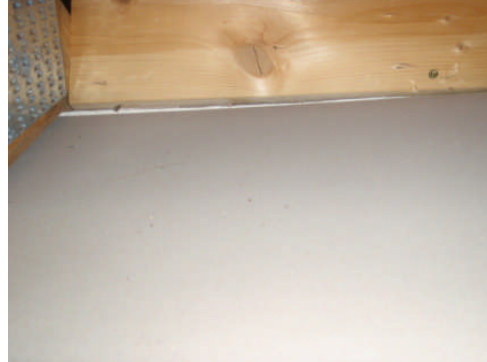
No visible insulation at peak areas

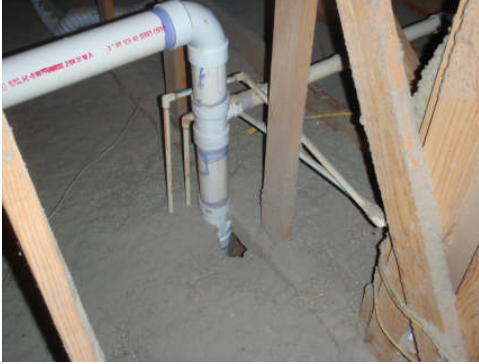
Water supply lines to second floor bathroom are not insulated as needed to prevent freezing. Broken pipes (if frozen) will cause significant damage to first floor areas.

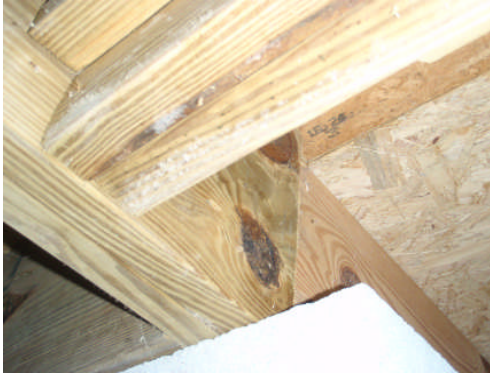
Piers sound/comments: sound. **Additional piers are needed to support sill joints through center/rear of house. This is apparent cause of bounce/shake in floor near large screen TV in den.**

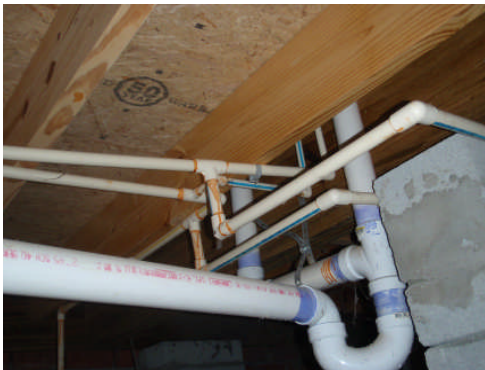
Joisting condition: sound...**no cross bridging/blocking installed as needed to stabilize long spans.**

Insulation (approx. R value): **None installed...R-19 is needed to meet SC Energy Code in effect since 1984. Lack of insulation is also causing metal of duct "boots" to sweat and has filled some flexible sections with water. Replacement of these sections is needed.**

No sub floor insulation, no blocking/cross bridging, no pipe insulation

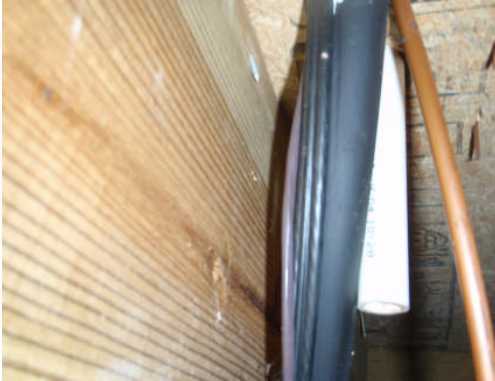
Condensation drain line from second floor HVAC air handler is draining under house and piping to exterior of foundation is needed

Condensation drain line (white) empties under house

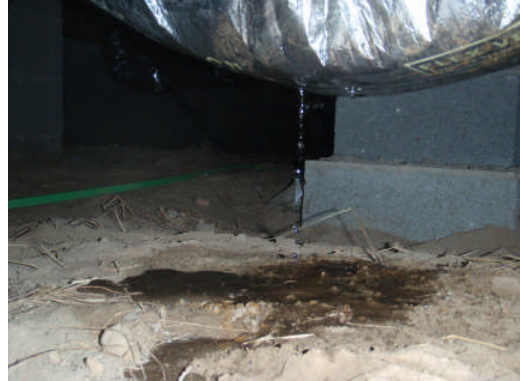
Some ductwork (flex line) under house is full of water and replacement is needed (condensation due to lack of insulation as noted in Crawl Space comments)

Ductwork under kitchen area full of water

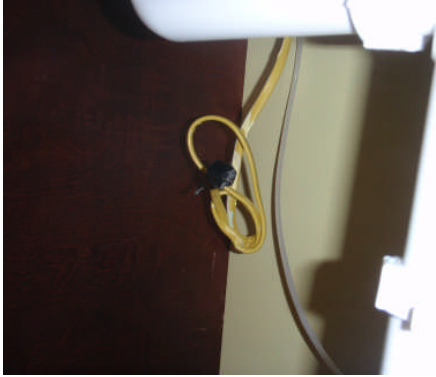
Disposal: none installed at time of inspection. Electrical line for disposal is not properly enclosed/capped and is considered a hazardous condition until disposal is installed.

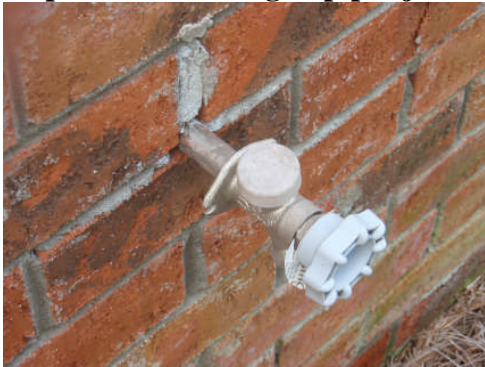
Exterior outlets functional: yes, **hose bibs are not properly secured to wall of house as needed to prevent breaking of pipes/joints**
