Herdt Home Inspections

Date of Inspection: August 7, 2023

Inspection #: 2230804

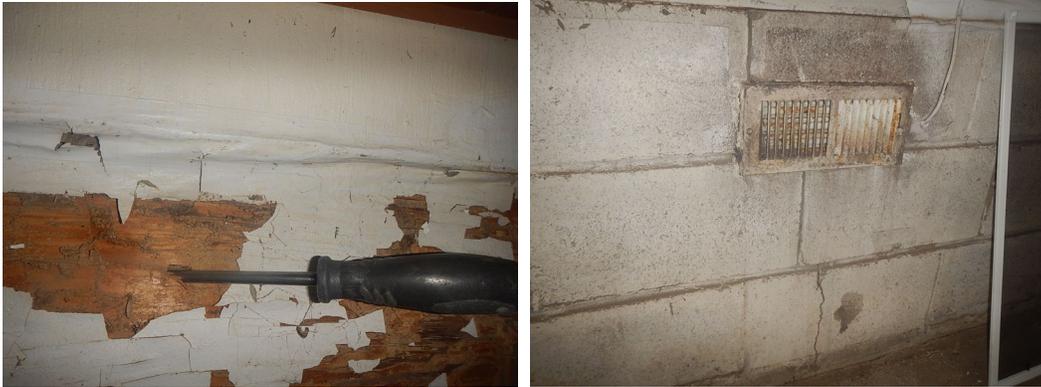
There is visible termite damage to sill of house near vehicle door. This damage is structural in nature with repair of sill needed. It is not known if there is significant damage to wall system above sill with removal of wall covering and evaluation by a licensed contractor needed. See also Crawl Space comments.

Crack through body of concrete block below termite damage should also be evaluated for any needed foundation repair in this area

Screwdriver through wood of sill girder at garage (left) and crack through body of concrete block

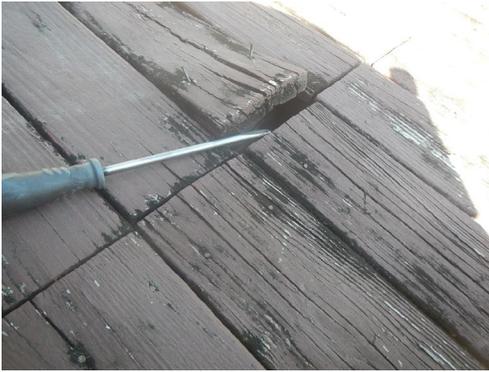
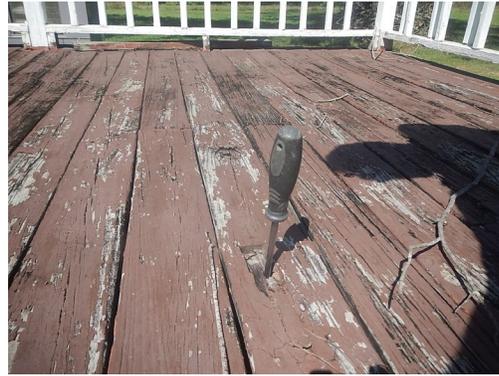
Wood deck on rear has some significant damage to wood members with repair needed to be considered safe. Framing/support of deck also requires correction/stabilization to prevent failure. This is potentially hazardous and could cause injuries should deck collapse.

Curling decking boards are a trip hazard and significant rot damage allows penetration of wood with screwdriver

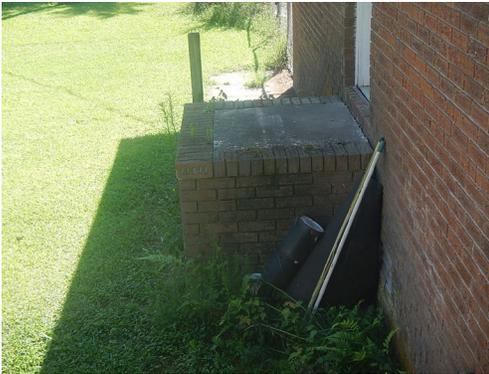
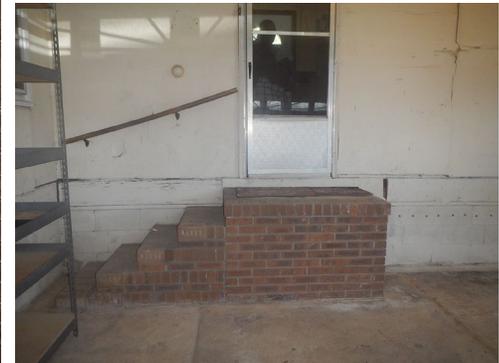
Lack of handrails on outside edges of stoops and steps would allow falls if walking straight out rear door (left) and into garage (right)

Slab on fill stoop from house into garage has brick surround and steps and is sound. ***The addition of handrails to outside edge of steps and stoop is strongly recommended.***

Rear stoop from laundry room has slab on fill floor, brick surround and steps and is sound. ***The addition of handrails to outside edges and steps is strongly recommended to prevent walk off type injury. Railings were not required by local standards for porches/steps of the height found at this residence when built. The addition of railings is a recommended/optional safety improvement to prevent falls.***

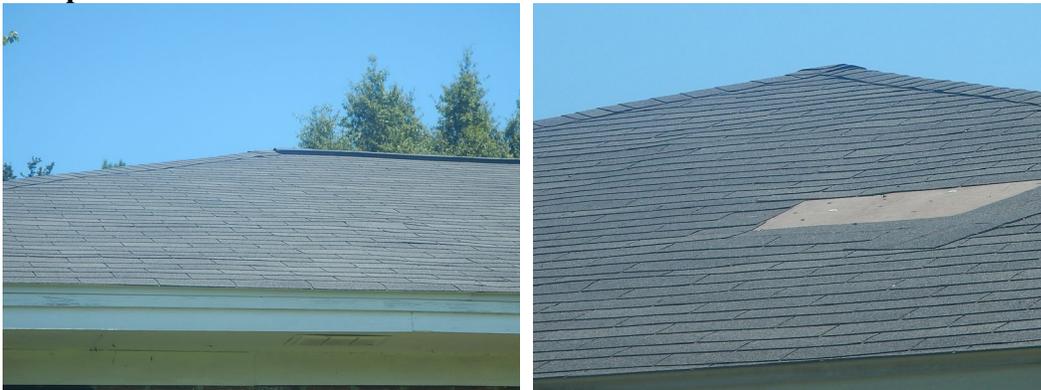
Shingle Condition: **Wind damage on front face and west face imply improper application (exposed decking with no underlay present) and nailing. Evaluation of entire roof by a reputable licensed contractor is needed.**

Broken/missing tabs of shingles on front face (left) with shingle slippage (right) on west face exposing plywood decking panel with no visible underlay (roofing felt/tar paper or other material installed

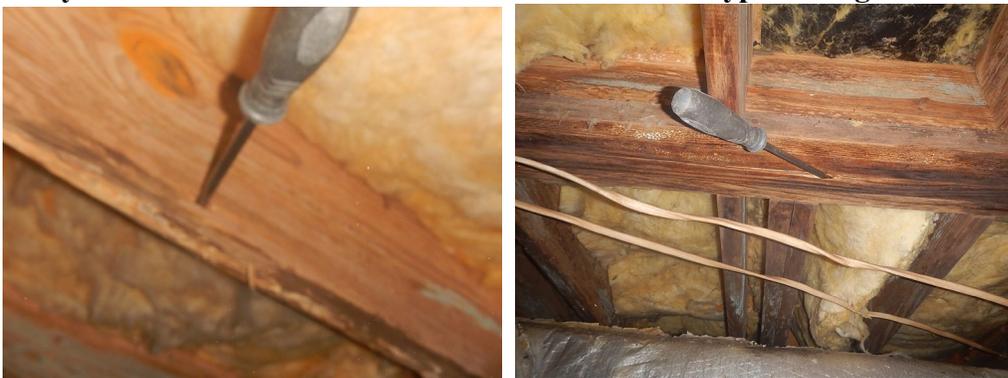
Joisting condition: **Areas of joisting have damage from termite activity that requires repair/augmentation. There is also damage from elevated moisture levels (condensation beading on wood members) in some areas. Entire floor system should be evaluated/corrected by a licensed contractor that is familiar with this type damage.**

Screwdriver completely through joist at termite damage (left) and embedded in wood members (right) that have been damaged by elevated moisture levels

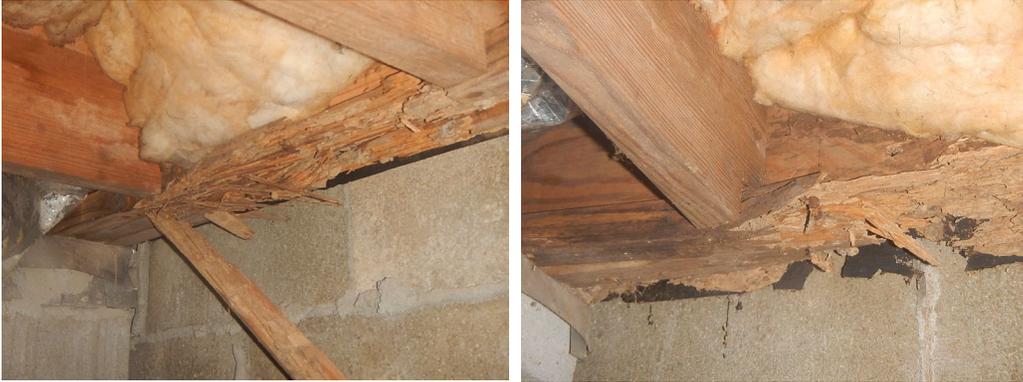
Sill Problems or other concerns: **Extensive damage to sills (girders) exists at widespread areas. These include but are not limited to areas adjacent to garage and garage storage/utility closet, front porch area and rear of house adjacent to fireplace/chimney and deck.**

Sill girders at garage area (left) and behind front porch (right) are literally falling apart with ledger support boards completely missing in some areas

Full evaluation during repairs is needed to assure proper correction.

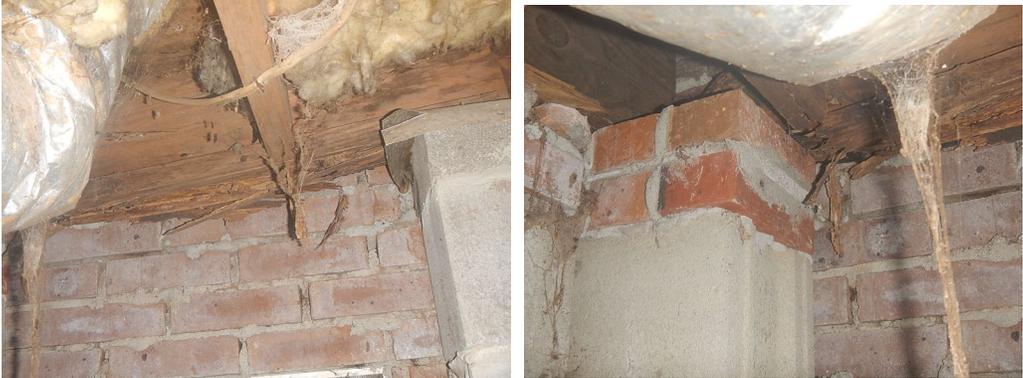
Sill at chimney/fireplace area has collapsed (note wood is lower than supporting pier on left) with significant damage to other floor system members in this area

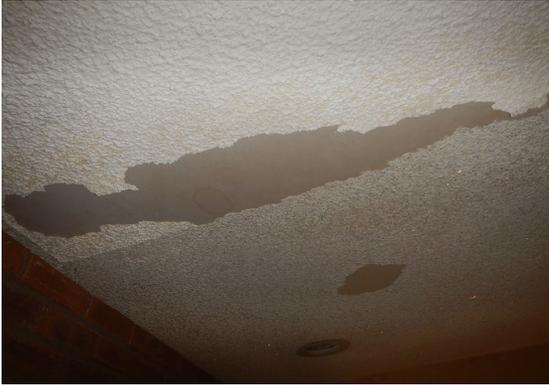
Floor of den adjacent to fireplace has a significant dip with visible flex/movement when walked upon. See Crawl Space comments.

Ceiling of den has damage to finish (flaking/peeling) that is assumed to be a result of old roof leaks. This is also true of other stained/discolored areas of ceilings and walls.

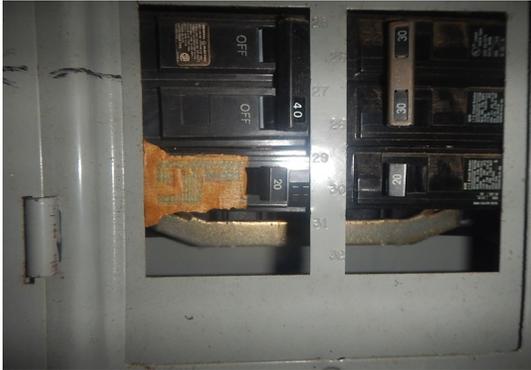
Open slots/missing circuit breakers expose electrical connections to accidental contact with correction needed to eliminate life hazard

Blanks are needed to cover openings in panel box cover

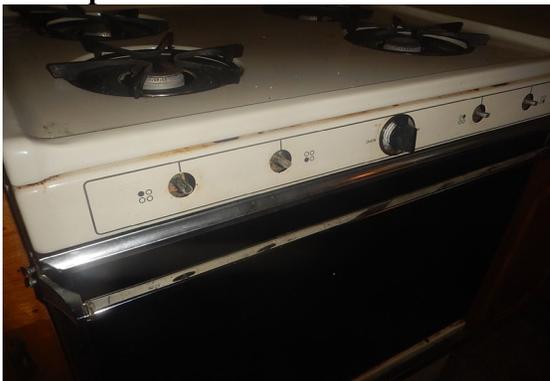
Oven: Roper free standing LP gas range could not be observed in operation (no gas tank). There is no anti-tip bracket in place as needed to eliminate hazardous condition. Cleaning cycle on self-clean ovens not tested due to time restrictions. Accuracy and function of thermostat, timers and clocks was not inspected or calibrated in any way.

Stove/Cook Top: Roper LP gas range has four standard burners that could not be observed in operation...there also are no control knobs in place for burners

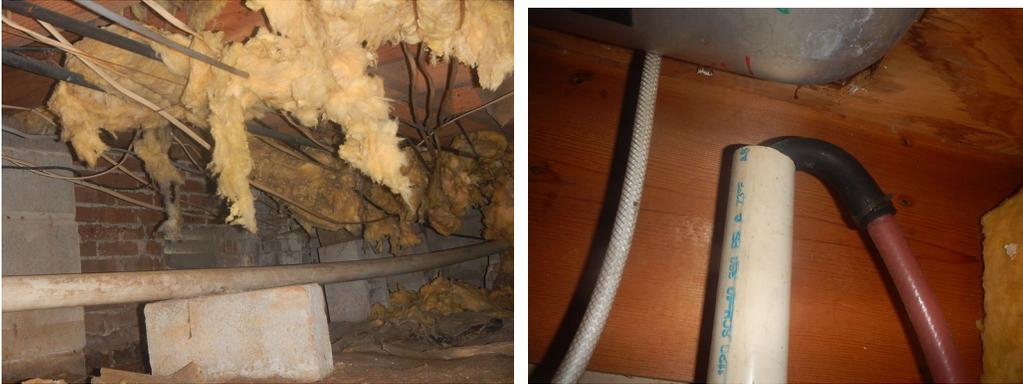
Waste line material: PVC plastic. **Proper support/elimination of belly/sag in waste water lines (in crawl space) is needed to prevent clogging.** *Materials are reported when they are observable--all plumbing lines run underground at some point and material contents in these areas are not observed.*

Waste water line from dishwasher is slip fitted into open pipe to septic system. A sealed/mechanical connection is needed to prevent sewer gases from entering house and also to prevent over flows.

Belly in waste water line (white on left) will cause clogging and improper insertion of dishwasher drain line into waste water system (right)

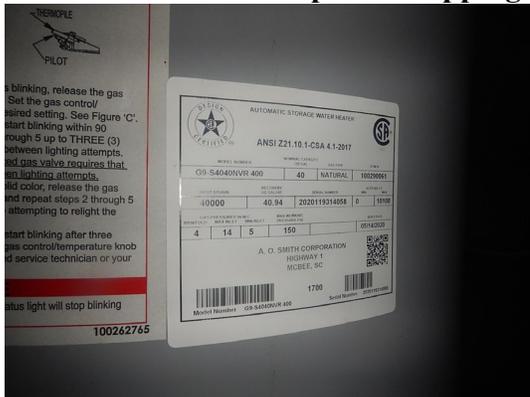
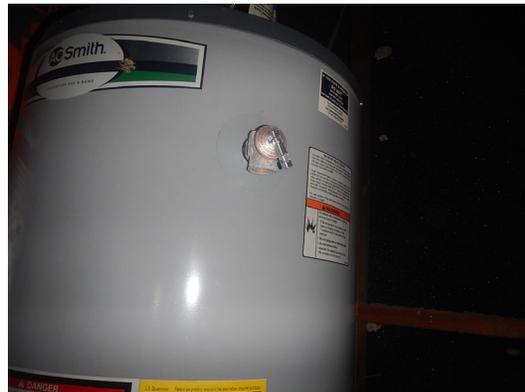
Pressure relief valve installed and properly vented to exterior or floor: **Valve is in place but is not piped to exterior as needed to prevent scalding and/or damage in event of valve activation**

Unit labeled for natural gas (left) with no indication of proper conversion to use LP gas and brass TPR valve (right) with no vent pipe installed

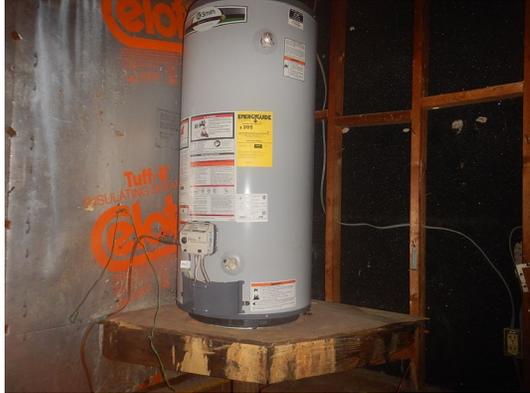
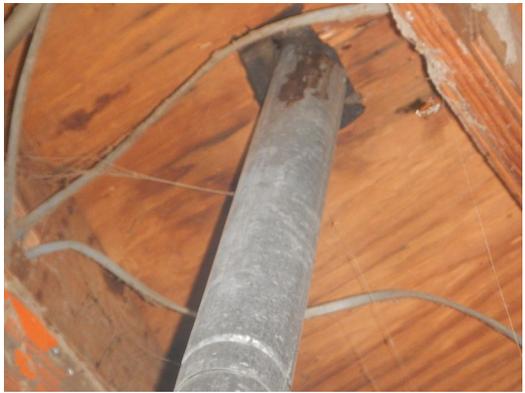
Condition of Vent/Flue: **flue is in direct contact with wood of roof system and is considered a fire hazard**

Leak pan installed as needed/recommended: Pan is not required. **Unit is not strapped to wall as needed to prevent tipping**

Water heater is not strapped to wall member as needed to prevent tipping (left) and metal flue is in direct contact with wood of roof system (right)

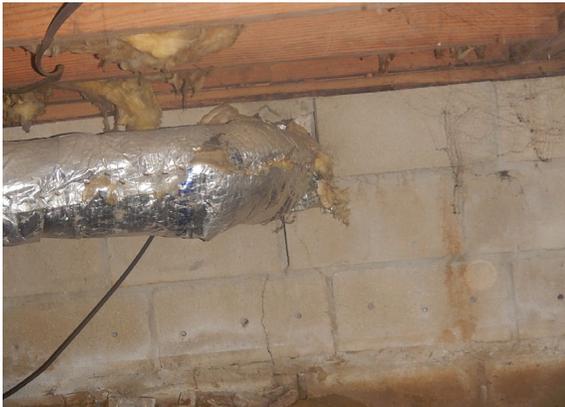
There is a duct from HVAC system that serves garage. This is a life hazard (can allow CO into ductwork/house with separation of this duct along with proper capping needed.

Duct into garage, also note cracks in concrete block wall from foundation failure
